# Tool Damage and Adhesion Effects in Turning and Drilling of Hardened Steels

**Keywords**—Turning, drilling, adhesion, wear, hard steels.

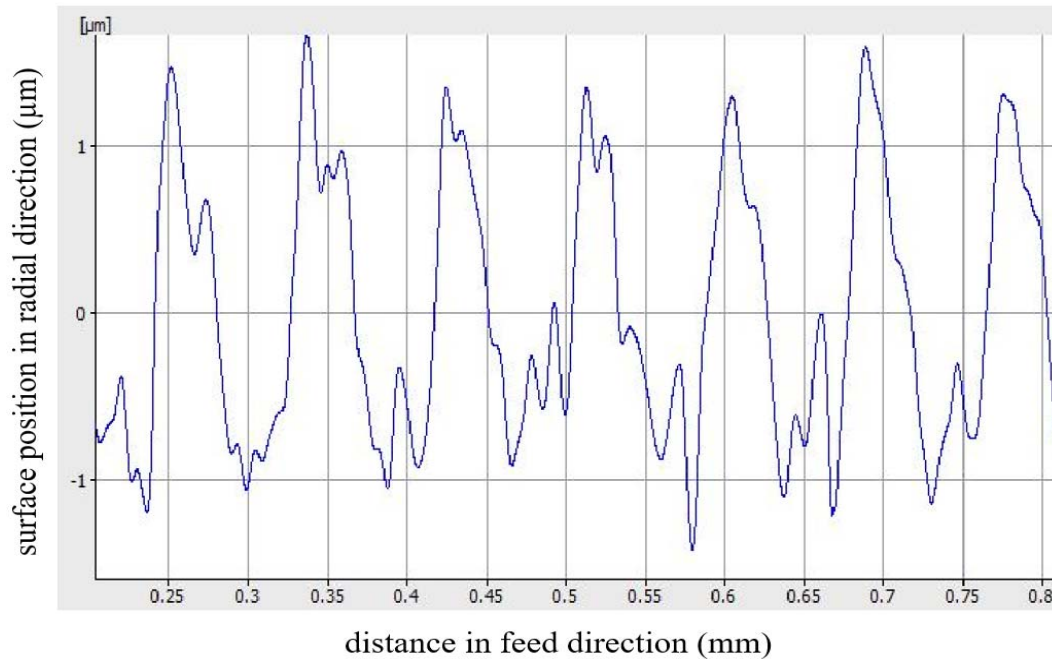
Fig. 3 Turned surface profile, in plane perpendicular to cutting speed direction

The hypothesis to explain this behaviour is that the geometrical effect of adhered workpiece material superimposed onto wear on the cutting edge is what is creating the variable profile cut into the bar's surface and causing the variation in surface roughness. This is borne out by the way in which surface roughness fluctuates independently of the size of the wear scar (Fig. 2), and by the cross-sectional profile measured on the turned surface (Fig. 3). Adhesion causes short-term fluctuations in the surface roughness, whilst tool wear leads to a long-term upward trend in surface roughness (only seen in 2 out of 3 repeat tests). From examination of the turned surface data in Fig. 3, the cross-sectional profile of the surface in the direction of tool feed can be observed to have a cyclic wave-type pattern with a wavelength of 0.088 mm. Note that the tool feed and workpiece rotation combine to create a helical cutting pattern. 0.088mm is the feed per revolution of the turning operation, equivalent to the pitch of the cut helix. However, the exact appearance of each wave profile varies noticeably at each revolution of the bar. Fig. 3 is a scan of the surface created at the end of repeat wear test number 2, where the highest surface roughness was measured. The cut wave profile corresponds to the true profile (shape) of the cutting edge, similar to the case of a serrated knife moving through butter. The nominal shape of the cutting edge is a circle arc, as the tool insert was created with a 1.6 mm radius nose, but the true profile cut into the workpiece surface is far from a circle arc. The profile of the cutting edge has been modified by the joint effects of adhesion and wear. Each revolution of the bar occurs in less than one second, the tool wear occurring in this time period is minimal so the rapid change of profile observable from wave to wave in Fig. 3

cannot be explained by tool wear. The proposal is that adhesion or BUE on the tool cutting edge has a large effect on the instantaneous surface finish of the turned bar.

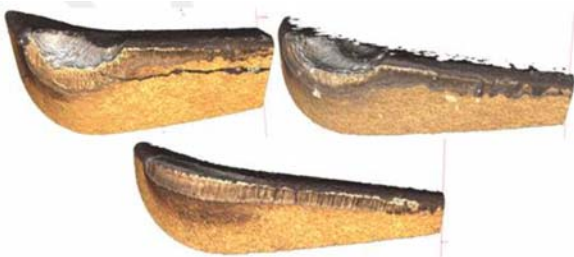
Fig. 4 High resolution 3D scans of tools after 15 minutes' turning

Fig. 4 displays high-resolution scans of the three turning inserts used in these trials. Moving clockwise from the top left, the inserts are from repeat trials 1, 2, and 3 as discussed. The rake face coating is black in colour; the insert flank coating is lighter in colour. The thin edges between the black surfaces and lighter-coloured surfaces are the cutting edges. The reflective silvery material visible in damaged areas along the cutting edges is adhered workpiece material. The uncoated tungsten carbide and cobalt substrate would appear as matt grey, but any areas where the coating has been removed are now covered in adhered material. Many thin “track” or “groove” damage features can be seen on the tool flanks, particularly visible for insert 3. These are orientated perpendicular to the cutting edges, and are the result of abrasive flank wear. Additionally, crater wear can be seen on the rake face in the case of inserts 1 and 2, this is due to the motion and heat resulting from cut chips (swarf) flowing over the rake face.

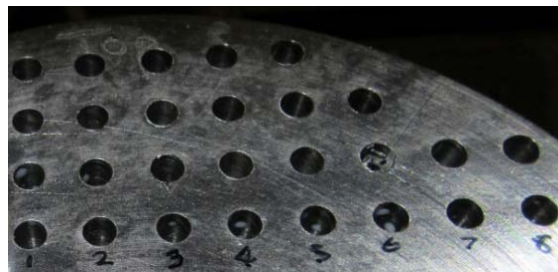
Fig. 5 Array of blind drilled holes in test piece surface

Drilling trials took place on a Starrag ZT1000 5-axis machining centre, which was chosen for its structurally-rigid machining head and a spindle speed of up to 24000 revolutions per minute. Blind holes were drilled to a depth of 50 mm with 4.5 mm diameter coated solid carbide 2-fluted drills. The hole depth is therefore 11 times the diameter. Fig. 5 shows an image of the drilled test holes. A shrink fit tool holder was used for all 4.5 mm drilling as shown in Fig. 6 (a). This holder provided a high grip force and low tool runout (or eccentricity), being less than 10 micrometres in all cases. The cutting fluid was a water-based emulsion supplied at 6-8% concentration. All 4.5 mm drills featured through-tool coolant holes, coolant was supplied through the machine spindle to the tool with 70 bar supply pressure.
